LAKE FACT SHEET (2017)

NORTH OTTER LAKE

**CATARAQUI REGION
CONSERVATION AUTHORITY**

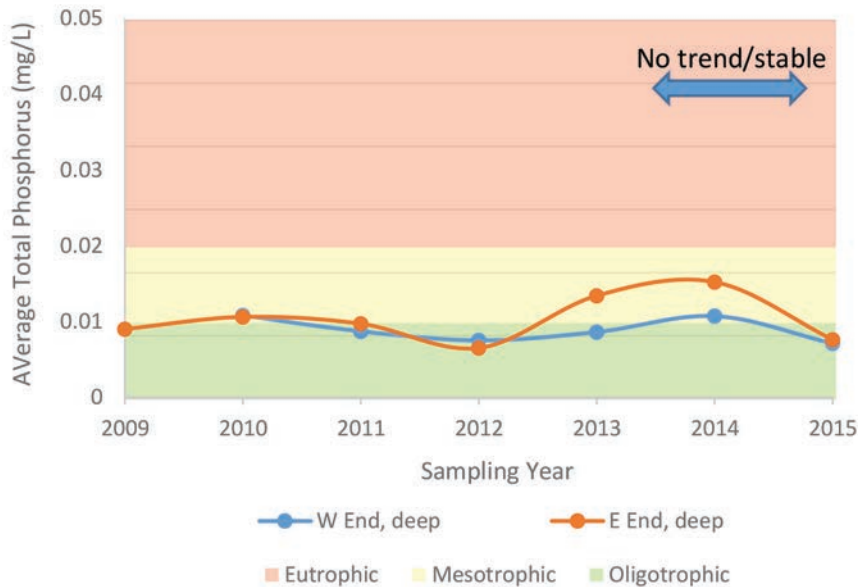
Water Quality Summary

Thermal Regime:	Coolwater	Total Phosphorus (mg/l):	0.0096 ¹
Dissolved Oxygen (mg/l):	No data	pH:	No data
Trophic Status:	Oligotrophic ¹	Average Calcium(mg/l):	4.48 ²
Average Secchi Depth (m):	3.9 ²

The average Secchi disk depth and average total phosphorus concentration show North Otter Lake to be on the border of mesotrophic and oligotrophic status. This is indicated in the total phosphorous, as levels have been both above and below the oligotrophic line.
